Welding of Gas-Tight Pipe Walls Made of Composite Pipes of 3R12/4L7 Steel

Stanisław Lalik ^{1,a}, Jarosław Adamski ^{2,b}, Andrzej Balcerzyk ^{2,c}

¹ Silesian University of Technology, Material Science Department,
Kraśińskiego 8, 40-018 Katowice, Poland

² Foster Wheeler Energy Fakop
Staszica 31, 41-200 Sosnowiec, Poland

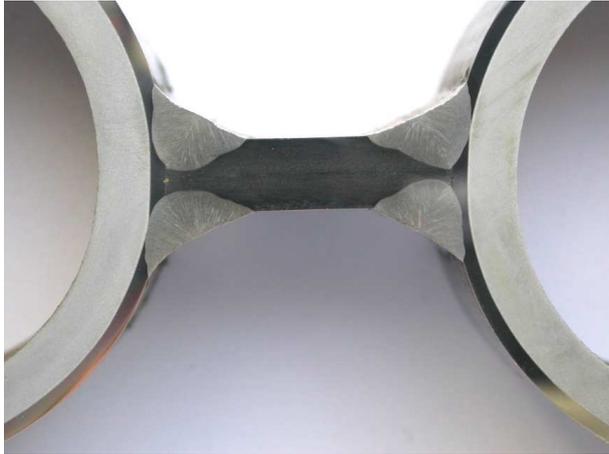
Fig. 1. Macrostructure of the welded joint

Metallographic tests. The macro- and microstructure tests were performed on welded joints cut from a section of a membrane wall. The welded joints were selectively etched. Pipes of 3R12 steel, flat bar of X6CrNi18-10 steel and welds were electrolytically etched in 10% water solution of oxalic acid at the voltage of 4 V. Pipes made of 4L7 steel were chemically etched in 3% solution of HNO₃ in C₂H₅OH. The results of tests of the macrostructure of welded joints subjected to heat treatment are presented in Fig. 1 and of the microstructure in Figs. 2-4.

Macro- and microscopic tests of welded joints confirmed the correct structure of the joints that are free from welding non-conformities. All welds are fused into the outer pipe only (Fig. 1). The flat bar has austenitic microstructure with NbC carbide bands. A slight growth of austenite grains in the flat bar HAZ as well as partial dissolution of NbC carbides in the matrix at the fusion boundary of the weld have occurred (Fig. 2). Austenite grains with larger size (Fig. 3) than in native material are present in the HAZ microstructure of pipes made of 3R12 steel. The HAZ of the inner pipe of 4L7 steel has fine-grained ferritic pearlitic microstructure with decarburization of the 4L7 pipe surface occurred in the metallurgical process of composite pipe production (Fig. 4). Tested welds have austenitic microstructure with dendritic nature.

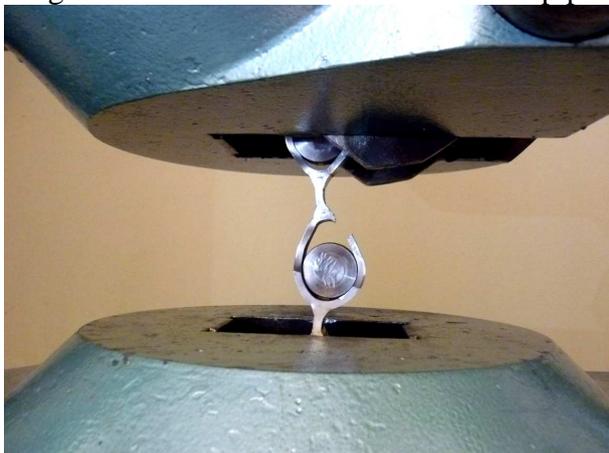
Fig. 5. View of the sample after rupture in the wall of the pipe

Mechanical properties of welded joints. To determine the tensile strength of welded joints of composite pipes with flat bars, the tensile test was performed on the membrane wall panel section. Tested samples were 20 mm wide. The rupture in the wall of the pipe occurred at 90 kN load. The view of the sample after rupture and the microstructure at this place are presented in the Figs. 5, 6. It was found that the sample rupture occurred beyond the welded joint and the delamination between the components of the composite pipe did not take place.
